## **Ground structure and its seismogeological characteristics influencing local seismic effects of the 1998 and 2004 Upper Posočje earthquakes in Slovenia**

*Mihael Ribičič*

University of Ljubljana, Faculty of Natural Science and Engineering,  
Department of Geology, Ljubljana, Slovenia

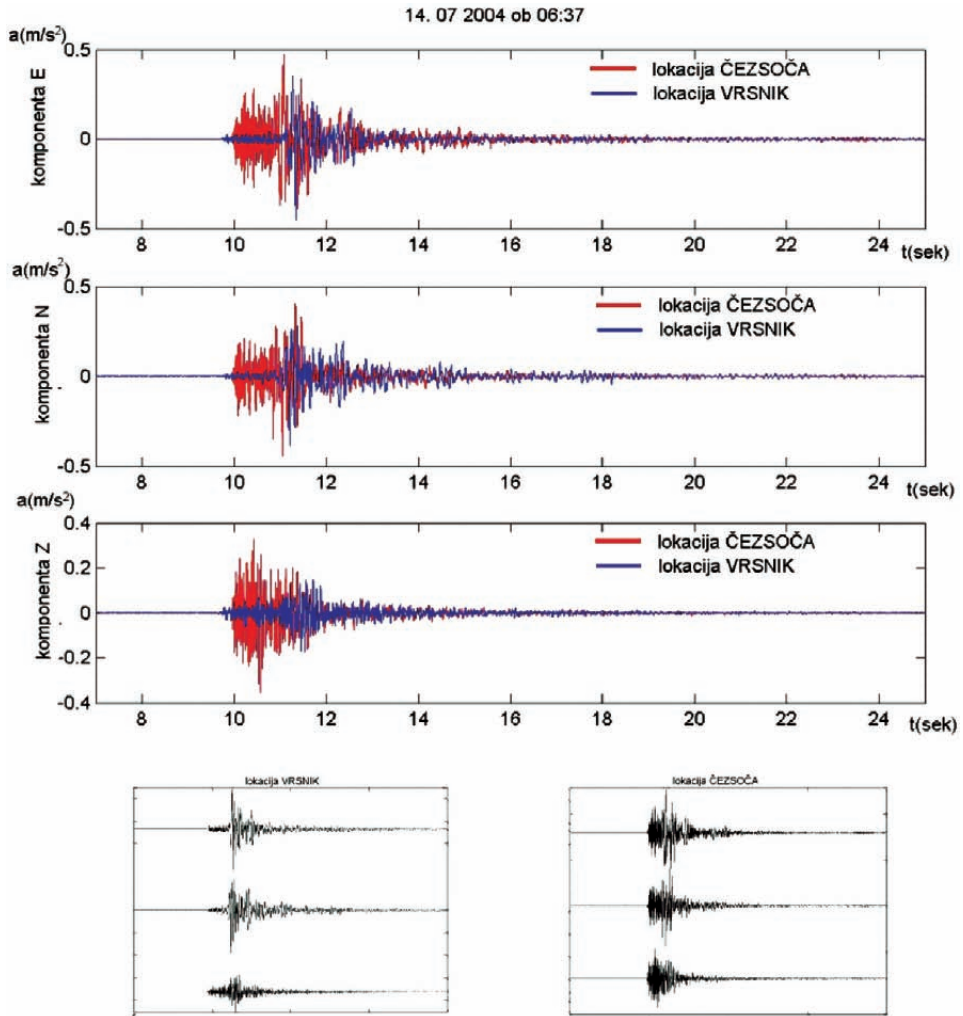
Nevertheless, the 2004 earthquake provided unexpected findings. In certain areas, especially in Čezsoča, the seismic effects were increased by a whole EMS scale degree, which is evident in the comparative diagram of seismic records obtained by two portable field-type seismic stations erected immediately after the earthquake, as shown below (Figure 2).

The initial primary wave recorded by the seismograph erected in the village of Čezsoča was substantially stronger than that recorded by the seismograph located in Vrtnik. It is assumed that one of the influential factors re-

**Figure 2.** Comparison of the records of the strongest aftershocks in Čezsoča (red) and Vrsnik (blue) occurring two days after the main earthquake in 2004.

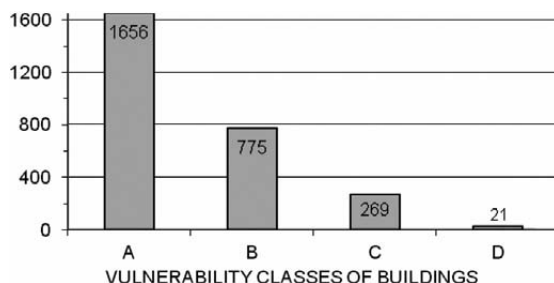
Figure 5. Vulnerability classes of buildings in the upper Posoče area.

The reasons for such large seismic effects on structures during the 1998 earthquake are actually based on their extremely high vulnerability, given that the majority of them fall into the two most vulnerable classes A and B (Figure 5).

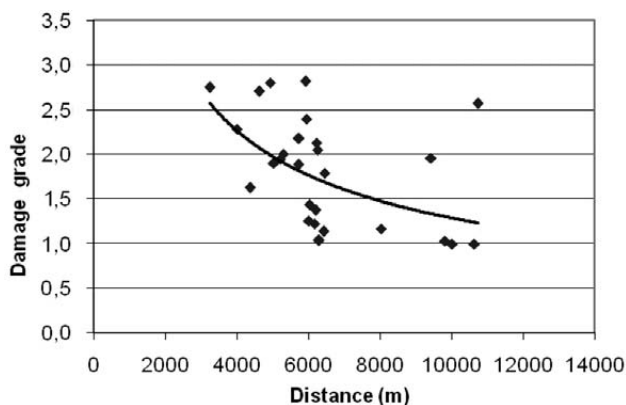
**Figure 6.** Correlation between the distance of sites from the epicenter and mean values of damage to structures.

The above diagram indicates a trend in the damage to structures decreasing in relation to distance. Moreover, the diagram shows that in the case of such small differences in distance from the epicenter, the structure of the ground has a greater influence on damage to structures than distance itself. In further analyses, the influence of the distance of sites from the epicenter was neglected.
