Investigation of the behavior of the cable-stayed bridge under test load

A field load testing is an effective method for understanding the behavior and fundamental characteristics of cable-stayed bridges. This paper presents results of the behavior of the reconstructed cable-stayed bridge over river Danube in Novi Sad under test load. The bridge was built between 1976 and 1981 and in 1999 was heavily damaged by two Tomahawk missiles. In 2003 process of the reconstruction began and at the end of 2005 Faculty of Civil Engineering, University of Belgrade was invited to test reconstructed bridge structure. The results of static load testing presented herein include displacements, rotations and strains of the 351 m long main span. Vibrations of the bridge were obtained by impact load produced by heavy truck passing the bridge and the time history response of vertical accelerations was recorded. The frequency content of the signals was determined using Fourier transformation and five flexural natural periods were extracted. The geological structure and engineering properties of the soil are also given. A finite element model of the bridge was made and a good agreement is achieved betwee

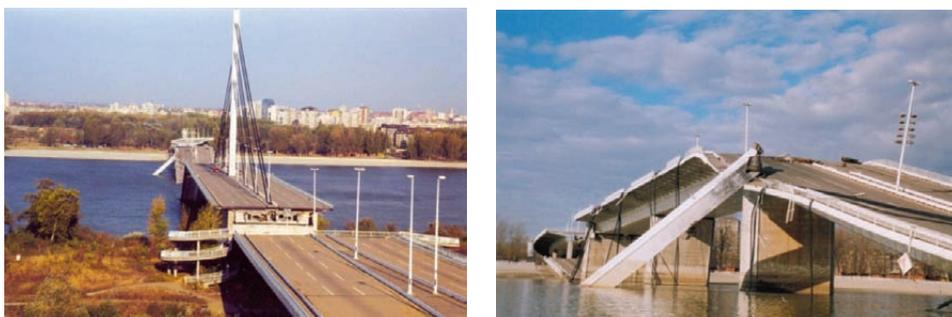
Figure 1. Damaged bridge structure.

The Sloboda Bridge was designed by Professor Nikola Hajdin and the Kirilo Savić Institute from Belgrade. The main contractor was Mostogradnja (Belgrade). The bridge was built between 1975 and 1981. On April 4th, 1999 two Tomahawk missiles launched by NATO forces heavily damaged the bridge structure.

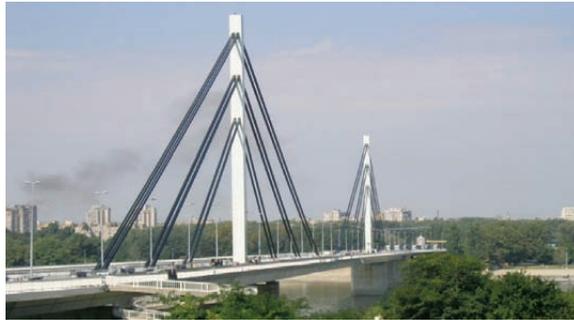
Figure 2. Reconstructed Sloboda Bridge.

Detailed descriptions of the bridge have been published previously (Hajdin, 1979; Hajdin, 1983); only the most important data will be given here. The bridge is composed of a main cable bridge and approach structures on the left and right Danube banks. The main cable-stayed steel structure has a $60 + 60 + 351 + 60 + 60$ m span arrangement. The pylons (60 m in height) are embedded into the deck structure. The cable stay system consists of six groups of stay cables, each composed of four stays positioned in the central vertical plane. At the time of the construction, the 351 m main span was the largest span in the world for a cable stayed bridge with stays in a single vertical plane.

The foundation system is composed of reinforced bored piles with diameters $\varnothing = 1200$ mm $\varnothing = 1500$ mm and connected using large RC pile caps. For the foundations of the main bridge (between piers 14 and 19, Figure 2) the following arrangement was used: 10 $\varnothing 1200$ (pier 14), 8 $\varnothing 1200$ (pier 15), 32 $\varnothing 1500$ (pier 16 – pylon pier), 24 $\varnothing 1500$ (pier 17 – pylon pier on the right river bank), 8 $\varnothing 1200$ (pier 18), 10 $\varnothing 1200$ (pier 19). The length of piles varies between 20 m on the left Danube bank and 35 m on the right bank.

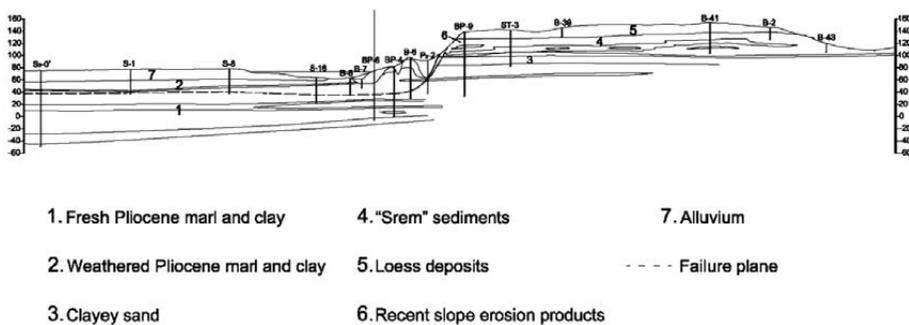
Figure 4. Engineering geological cross section.

Rocks are classified on the basis of engineering geological mapping and core examination into the following seven geotechnical units, (Figure 4):

- Fresh lake deposits (1)
 - Marl and clay (1/1)
 - Sand and silt (1/2)
- Altered, deteriorated deposits (2)
 - Weathered marl (2/1)
 - Soft clay (2/2)
- Clayey sand (3)

- “Srem” sediments (4)
- Loess deposits (5)
- Recent slope erosion products (6)
- Alluvial deposit (7).

The numbers in parentheses designate respective geotechnical units listed in the table of the mechanical properties of soil (Table 1).

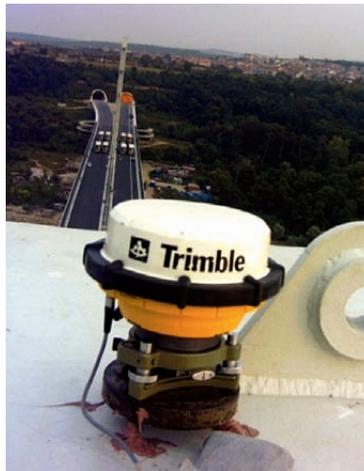
Figure 6. Displacement was measured using GPS technology.

Vertical displacements were measured in 23 cross sections of the bridge by surveying-leveling. Displacement of the top of the pylon was measured using GPS technology, with a TRIMBLE 4600LS receivers placed on the top of both pylons, as presented in Figure 6. The sensors received signals every 15 sec-

onds. The world coordinate system (WGS84) and appropriate software were used for vector analysis of displacement. Maximum horizontal displacement of the top of the pylon obtained by test was 55 cm. Calculated value is 58 cm.

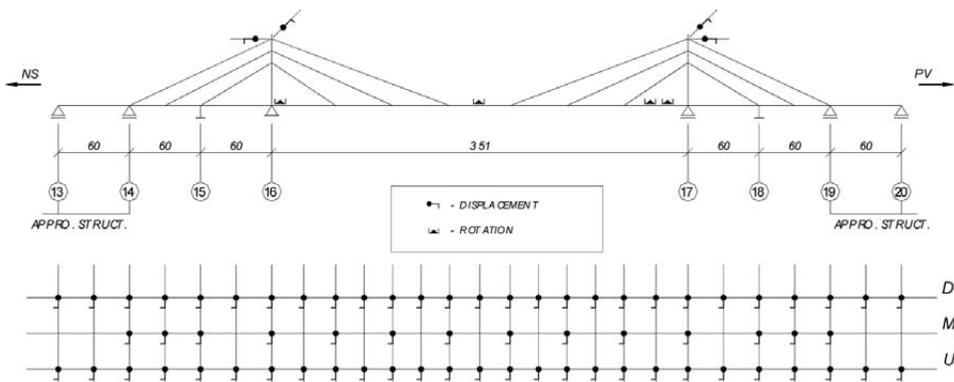
Figure 7. Position of measurement points for static tests.

At the end of reconstruction, before opening for traffic, the bridge was subjected to a load test. The bridge was tested using a trial load in accordance with code JUS U.M1.046. Dynamic characteristics of the structure were investigated together with global and local deformations of the bridge. Vertical deflections, horizontal displacements, rotations and strains were measured on the main bridge and two approach girders.

Position of measurements points for global deformation is presented in Figure 7.

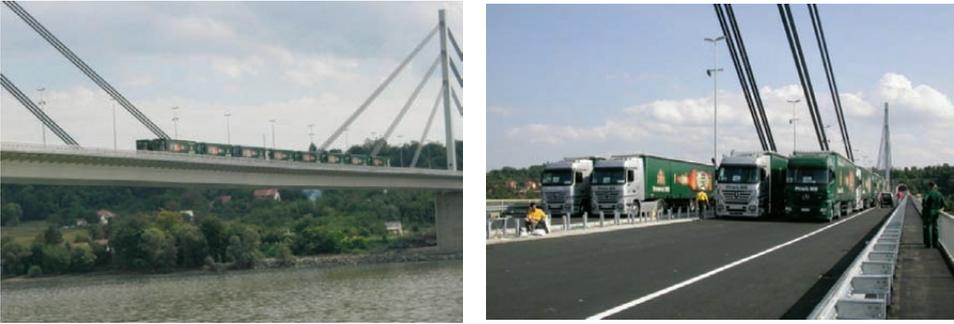
Figure 8. Trial static load.

The static load used was 20 heavy trucks, approximately 42 tones each, as presented in Figure 8. Intensity and positions of trucks for static load were calculated to produce 0.50–0.85% of maximum characteristic stresses.

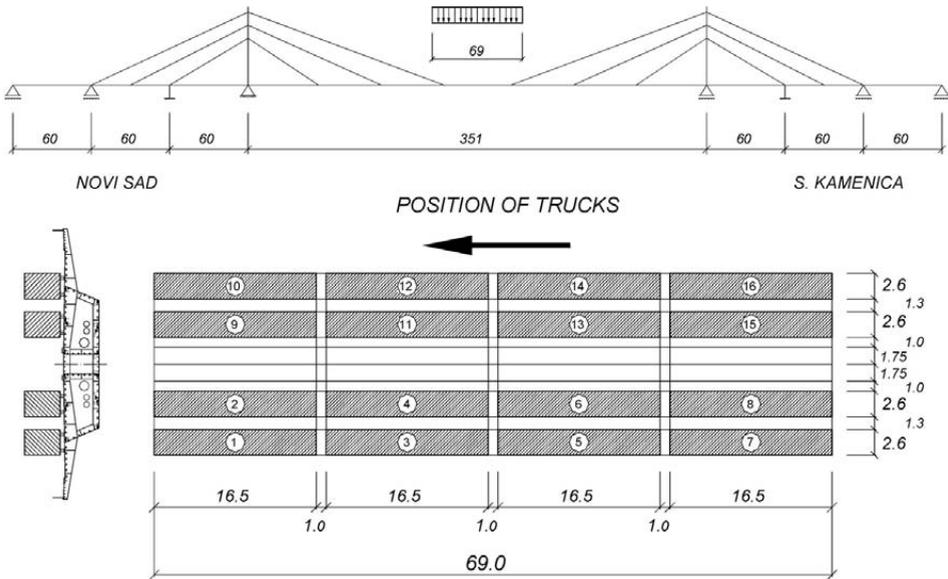
Figure 9. Load phase 1.

Static load was performed by 7 different phases.

In this paper it is presented load phase 1 which produces maximum stress in the middle of the bridge (Figure 9).

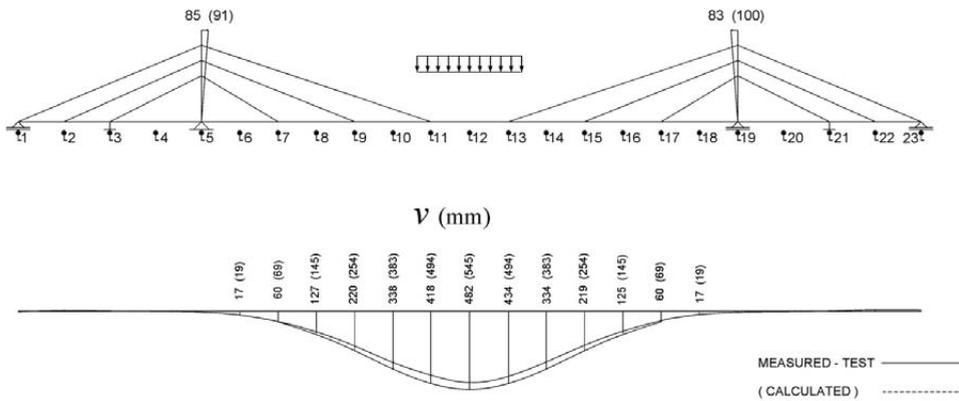
Figure 10. Vertical displacements (phase 1).

Maximum vertical displacements of main girder were obtained in the middle of the bridge and it was $v = 48.2$ cm. Corresponding theoretical (calculated) value is 54.5 cm (Figure 10).

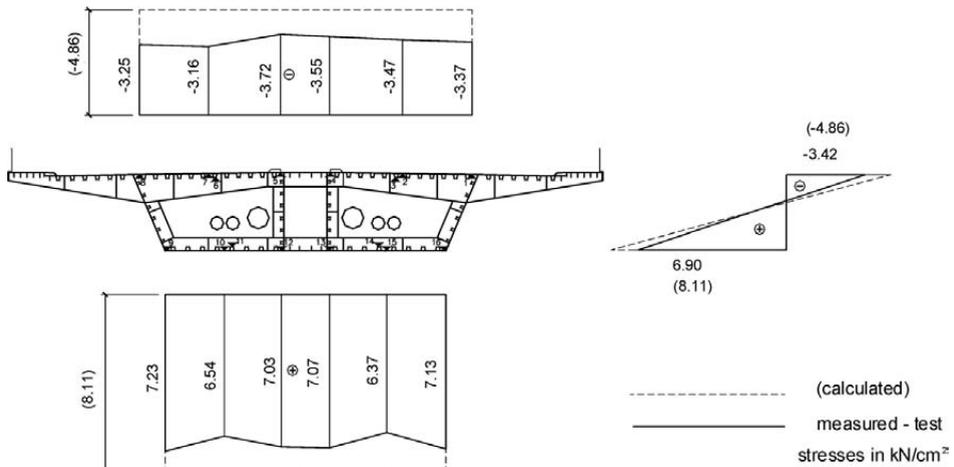
Figure 11. Normal stresses in the middle of the main span.

Distribution of normal stresses in the middle of the bridge is shown in Figure 11.

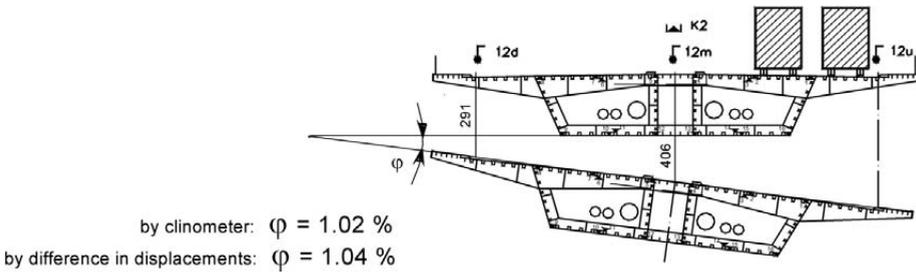
Figure 12. Torsion (rotation) of the bridge (phase 2)

Non-symmetric load in the phase 2, when the trucks are only in one lane, produced maximum torsion of the bridge cross-section. Measured value in the middle of the bridge was $\varphi = 1.04\%$. Theoretical rotation is $\varphi = 1.10\%$ (Figure 12).

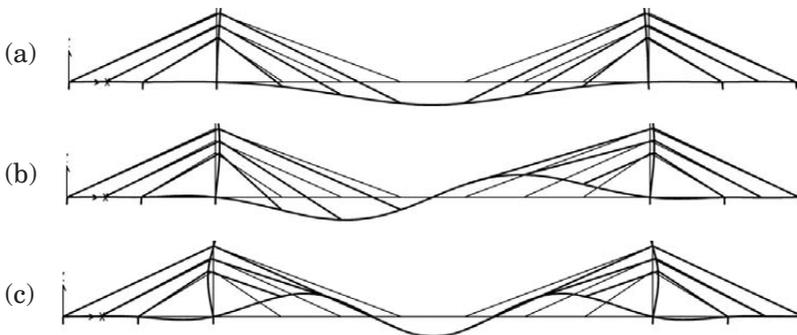
Dynamic numerical analysis was performed on the system with dead weight only (weight of the structure plus superimposed dead weight). Three characteristic flexural modes are presented in Figure 14.

Figure 14. (a) First mode ($f_1 = 0.40$ Hz) (b) Second mode ($f_2 = 0.64$ Hz), (c) Fourth mode ($f_4 = 1.00$ Hz).

Mode Number	1	2	3	4	5	6	7	8
Calculated (Hz)	0.40	0.64	0.98	1.00	1.47	1.96	2.08	2.70
Measured (Hz)	0.40	#	x	1.01	1.46	x	2.05	2.73

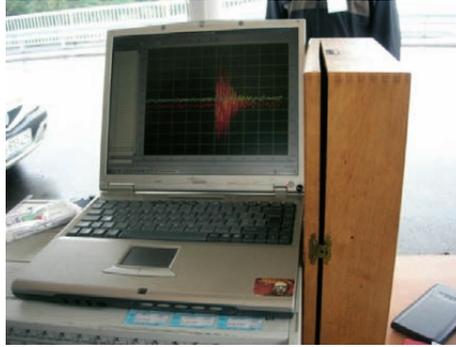
Figure 15. Recording the vibrations during testing.

Vibrations of the bridge recorded during testing are presented in Figure 15.

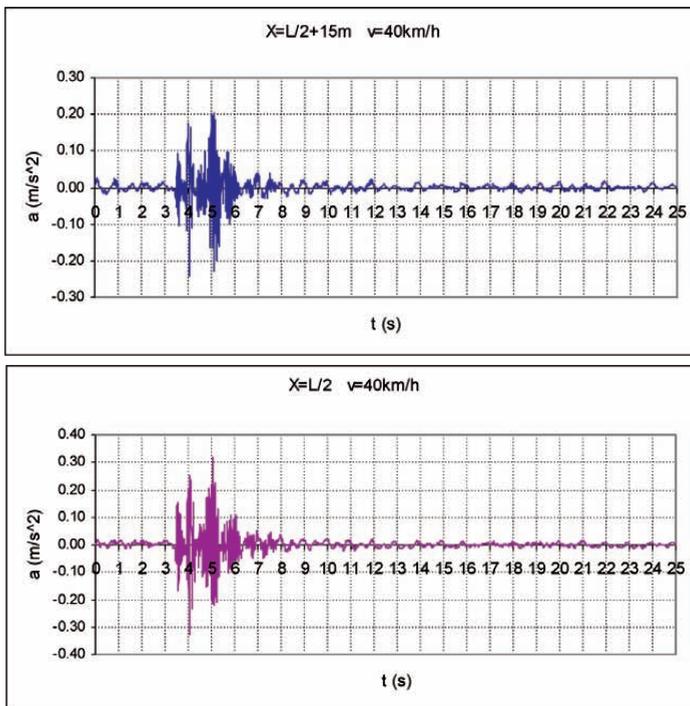
Figure 16. Time histories of acceleration at two locations.

were used for dynamic testing. To record vertical acceleration, accelerometers were placed at the top of the deck plate in the middle of the cross section at the following two measurement stations along the span: in the middle of main span (section 1-1) and 15 m away from section 1-1, at the position of the cross frame (section 10-10). These sections are shown in Figure 13.

In Figure 16 the time history of vertical acceleration at two measurement stations are shown.

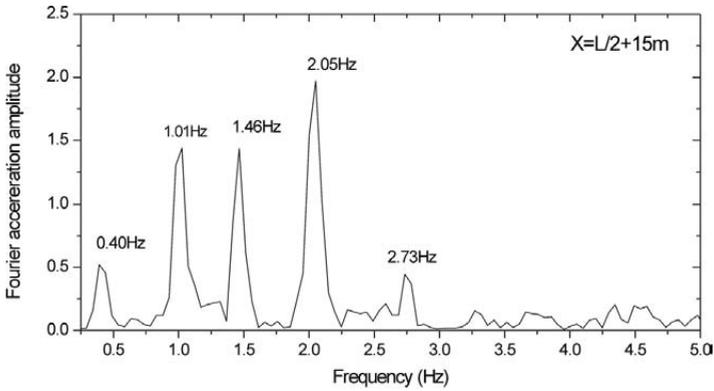
Figure 17. Amplitude acceleration spectrum – section $X = L / 2 + 15 \text{ m}$.

A Fast Fourier Transformation with $N = 2^{10}$ points spaced at intervals of $\Delta t = 0.02$ s was used to transfer the acceleration signals into the frequency do-

main with a step size of $\Delta f = 0.04883 \text{ Hz}$. The amplitude acceleration spectra for the two measuring points are given in Figures 17 and 18. From the obtained spectra, five natural frequencies were extracted.

ed. Note that the second mode (anti-symmetric) was not identified. This result may be due to the fact that at the position of the accelerometer ($x = L/2 + 15$ m) the theoretical modal amplitudes are very small, because the position was close to the mid-span. The torsional frequencies were not measured. The torsional response can be inferred only from the static tests.
